(71) Applicant: AIR PRODUCTS AND CHEMICALS,
INC.

(54) Heat treated chemically vapor deposited products and treatment method.

HEAT TREATED CHEMICALLY VAPOR DEPOSITED PRODUCTS AND TREATMENT METHOD

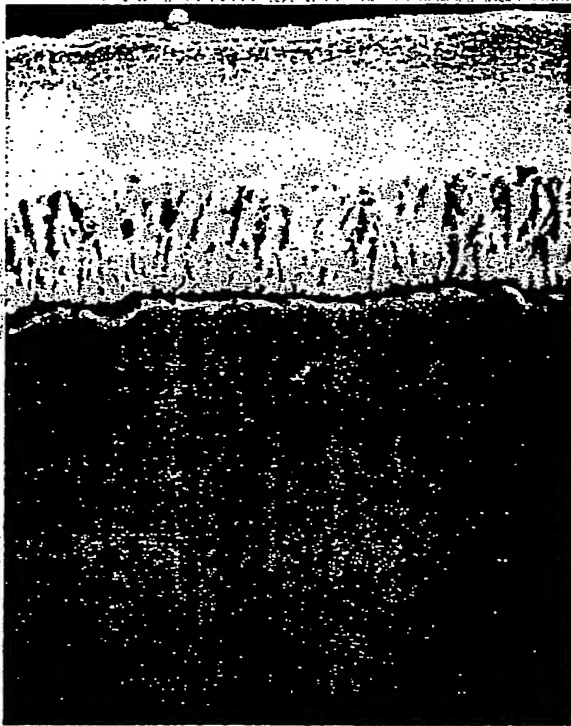
FIG. 1A

10 Figure 1A is a photomicrograph, magnified 2000 times, of an etched cross section of a coating system according to the invention on AM-350 stainless steel substrate in the as-deposited and unheat-treated condition showing non-uniform microstructure in the top one-fourth thickness of the tungsten/tungsten carbide layer.

The resultant product includes an outer layer of a tungsten/tungsten carbide which has a substantially layered and uniform microstructure substantially free of cracks. By viewing Figure 1A, the substantially layered microstructure of the deposit before heat treatment may be observed. It will also be noted that, although the deposit is substantially free of cracks, a somewhat non-uniform microstructure exists in the outer 25% of the tungsten/tungsten carbide layer. As may be seen in Figure 2A, the heat treatment removes this non-uniformity. Moreover, the data set out below demonstrate that the outer layer furthermore has a substantially high erosion and abrasion wear resistance than in the unheat-treated condition.

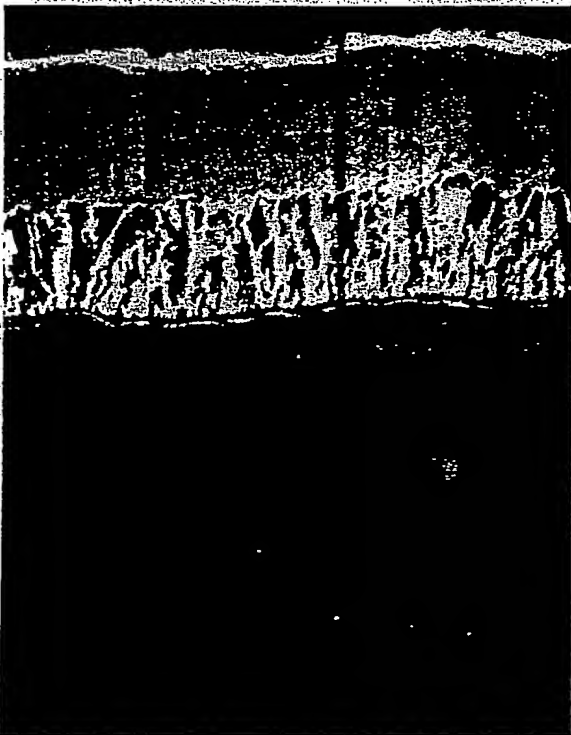
FIG. 1B

Figure 1B is a photomicrograph, magnified 2000 times, of an etched cross section of a coating system according to the invention on Ti/6Al/4V substrate in the as-deposited and unheat-treated condition showing non-uniform microstructure in the top one-fourth thickness of the tungsten/tungsten carbide layer.

The AM-350 and Ti/6Al/4V specimens were coated with $\sim 10.5\mu m$ tungsten followed by $13.3\mu m$ tungsten/tungsten carbide, as shown in Table 2. The tungsten interlayer had the well known columnar growth microstructure; whereas, the tungsten/tungsten carbide top coat had a fine-layered structure, as shown in Figures 3A and 3B. As noted in Example 3, the 120 minute post heat treatment eliminated the microstructural nonuniformity that was present without heat treatment (compare Figures 3A and 3B with Figures 1A and 1B). The tungsten/tungsten carbide coating, once again, had a surface finish of

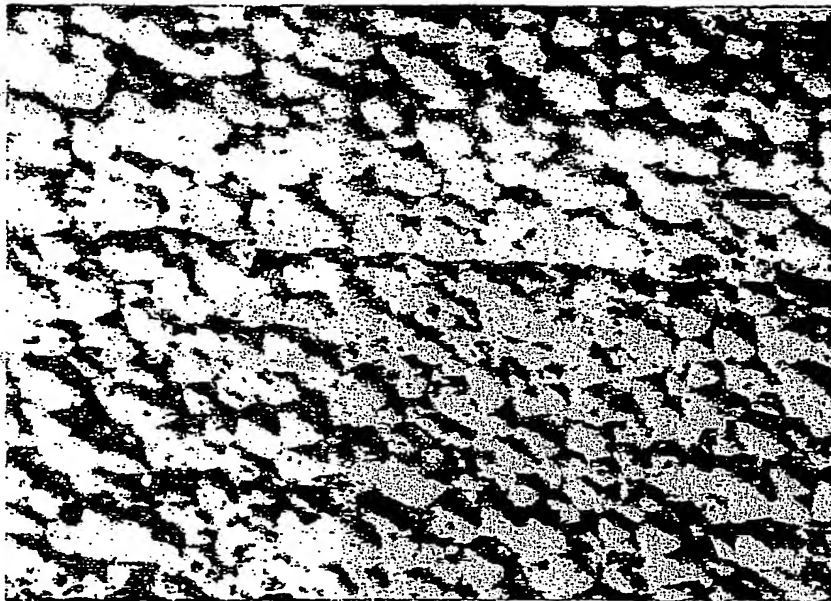
FIG. 1C

20 Figure 1C is a photomicrograph, magnified 1000 times, of a coating on AM-350 stainless steel showing the absence of cracks in the coating.

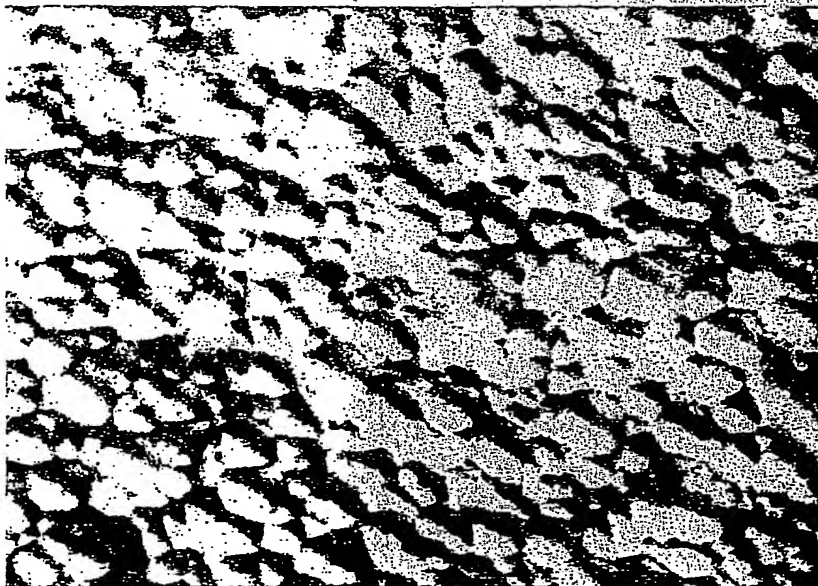
FIG. 1D

Figure 1D is a photomicrograph, magnified 1000 times, of a coating on Ti/6Al/4V showing the absence of cracks in the coating.

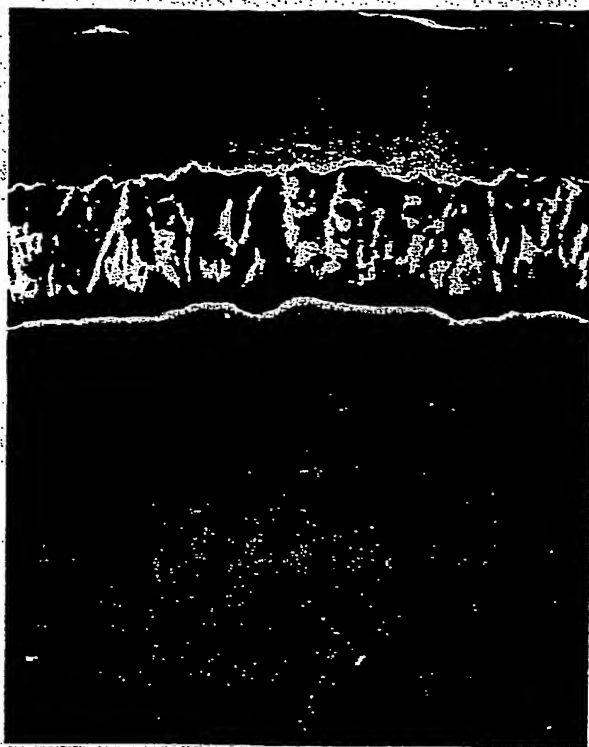
FIG. 2A

25 Figure 2A is a photomicrograph, magnified 2000 times, of an etched cross section of a coating system according to the invention on AM-350 stainless steel substrate heat treated in-situ for 60 minutes showing the absence of non-uniformity in the microstructure.

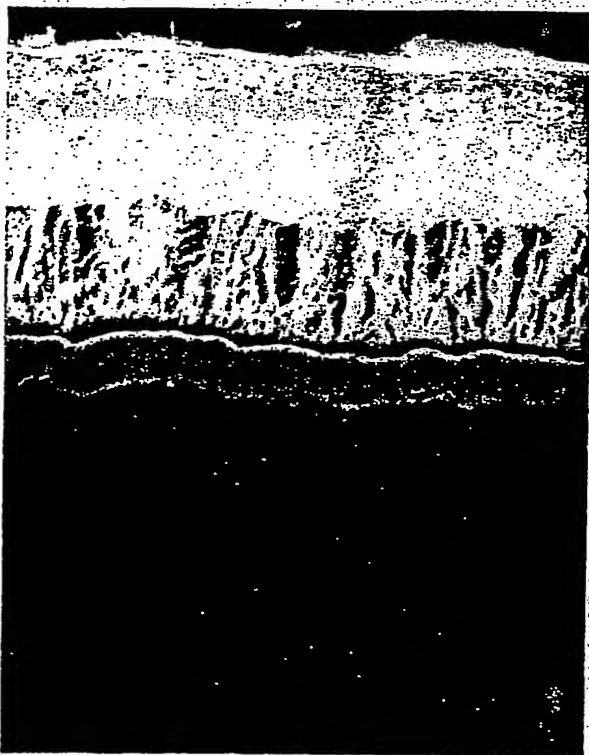
FIG. 2B

Figure 2B is a photomicrograph, magnified 2000 times, of an etched cross section of a coating system according to the invention on Ti/6Al/4V substrate heat treated in-situ for 60 minutes showing the absence of non-uniformity in the microstructure.

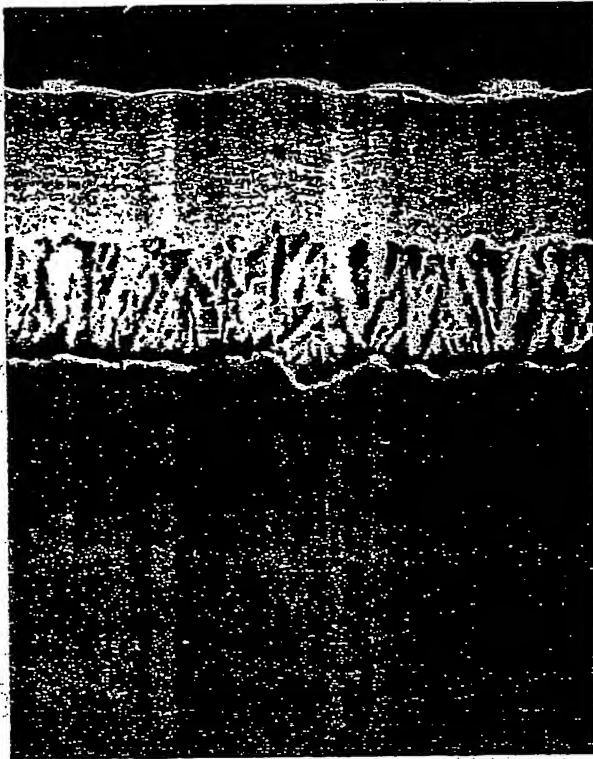
FIG. 3A

30 Figure 3A is a photomicrograph, magnified 2000 times, of an etched cross section of a coating system according to the invention on AM-350 stainless steel substrate heat treated in-situ for 120 minutes showing the absence of non-uniformity in the microstructure.

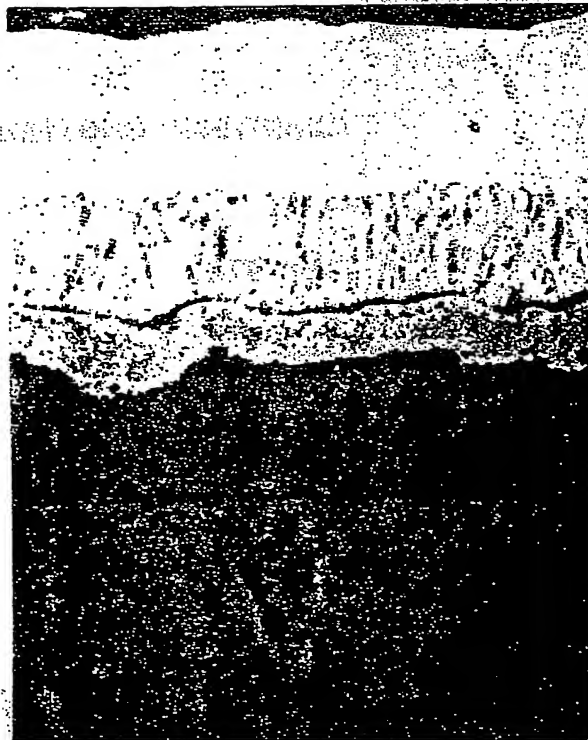
FIG. 3B

Figure 3B is a photomicrograph, magnified 2000 times, of an etched cross section of a coating system according to the invention on Ti/6Al/4V substrate heat treated in-situ for 120 minutes showing the absence of non-uniformity in the microstructure.

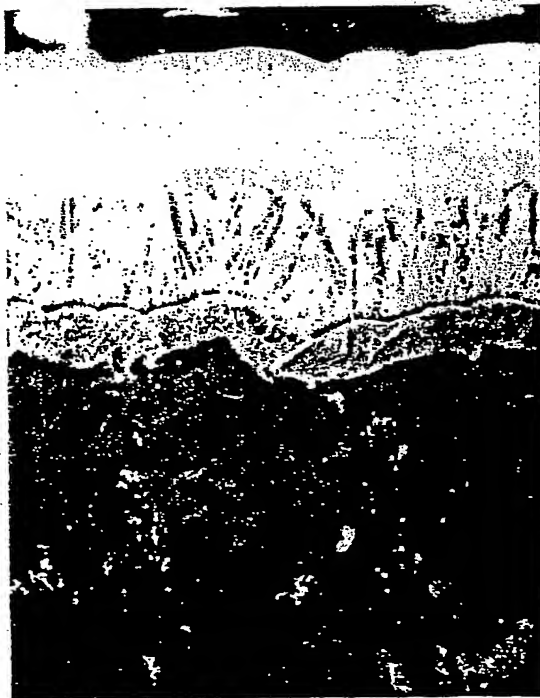
FIG. 4B

40 Figure 4B is a photomicrograph, magnified 2000 times, of an etched cross section of a coating system according to the invention on Ti/6Al/4V substrate heat treated externally for 60 minutes showing significantly reduced non-uniformity in the microstructure.

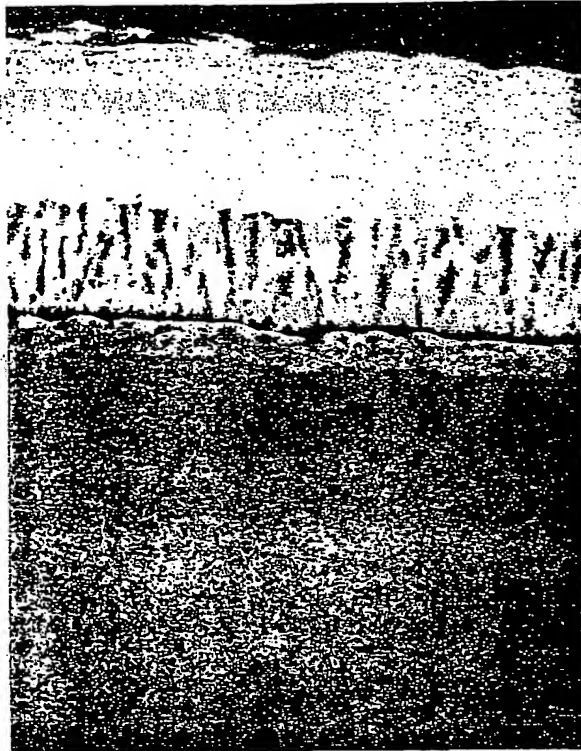
FIG. 5A

Figure 5A is a photomicrograph, magnified 2000 times, of an etched cross section of a coating system according to the invention on AM-350 stainless steel substrate heat treated externally for 1440 minutes showing the absence of non-uniformity in the microstructure.

Etched cross sections showed that the coating was microstructurally uniform after 1,440 minutes of heat treatment (see Figures 5A and 5B). No changes in coating composition and hardness, however, were noted with the post heat treatment. The erosion resistance of the coatings, on the other hand, improved by more than 13% (see Table 5). The erosion resistance of the coating on AM-350 stainless steel after 1,440 minutes of external heat treatment was very close to the value noted after 60 minutes of in-situ heat treatment. This data indicated that longer external heat treatment times were needed to match the improvements in erosion resistance noted with in-situ heat treatment. These differences,

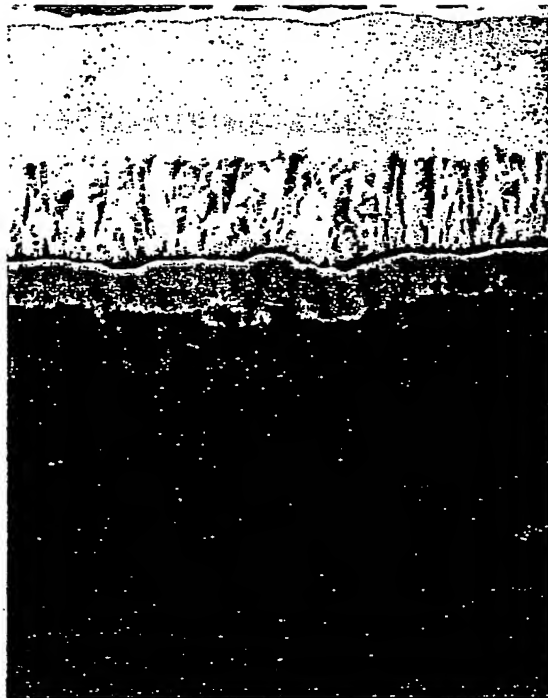
FIG. 5B

45 Figure 5B is a photomicrograph, magnified 2000 times of an etched cross section of a coating system according to the invention on Ti/6Al/4V substrate heat treated externally for 1440 minutes showing the absence of non-uniformity in the microstructure.

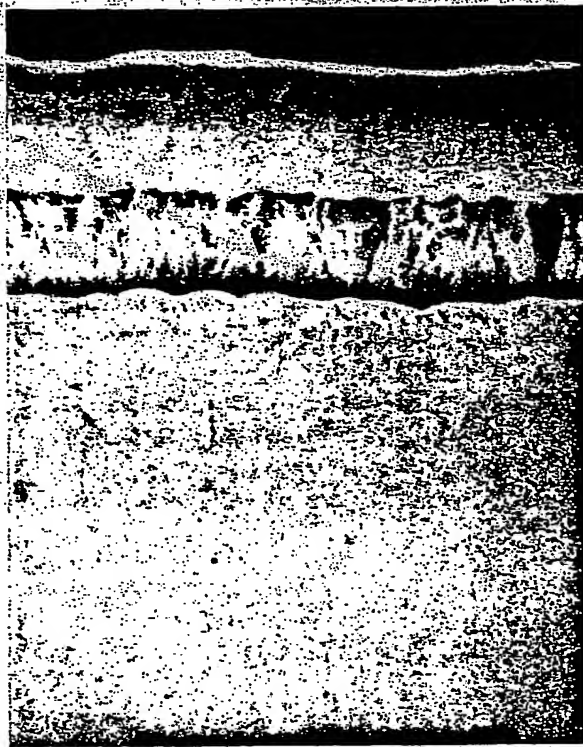
FIG. 6A

50 Figure 6A is a photomicrograph, magnified 2000 times, of an etched cross section of a coating system according to the invention on AM-350 stainless steel substrate heat treated in-situ for 60 minutes followed by external heat treatment for 720 minutes at 500 °C showing the absence of non-uniformity in the microstructure.

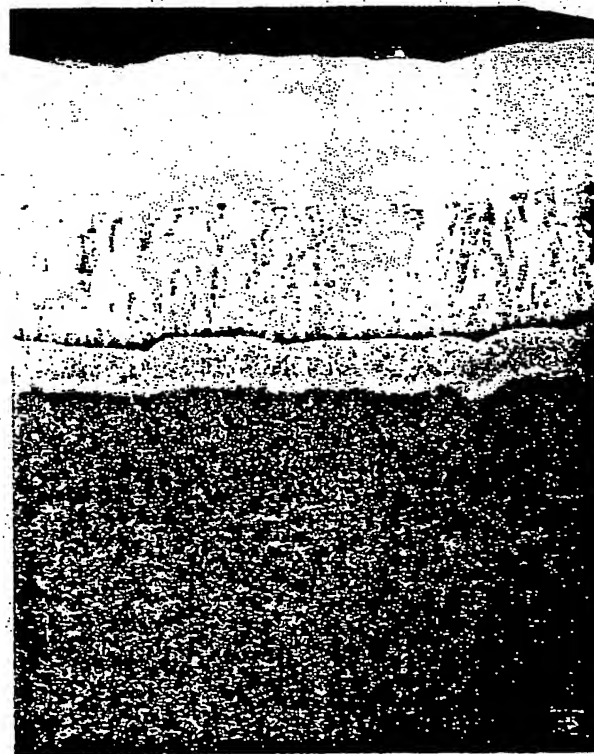
FIG. 6B

55 Figure 6B is a photomicrograph, magnified 2000 times, of an etched cross section of a coating system according to the invention on Ti/6Al/4V substrate heat treated in-situ for 60 minutes followed by external heat treatment for 720 minutes at 500 °C showing the absence of non-uniformity in the microstructure.

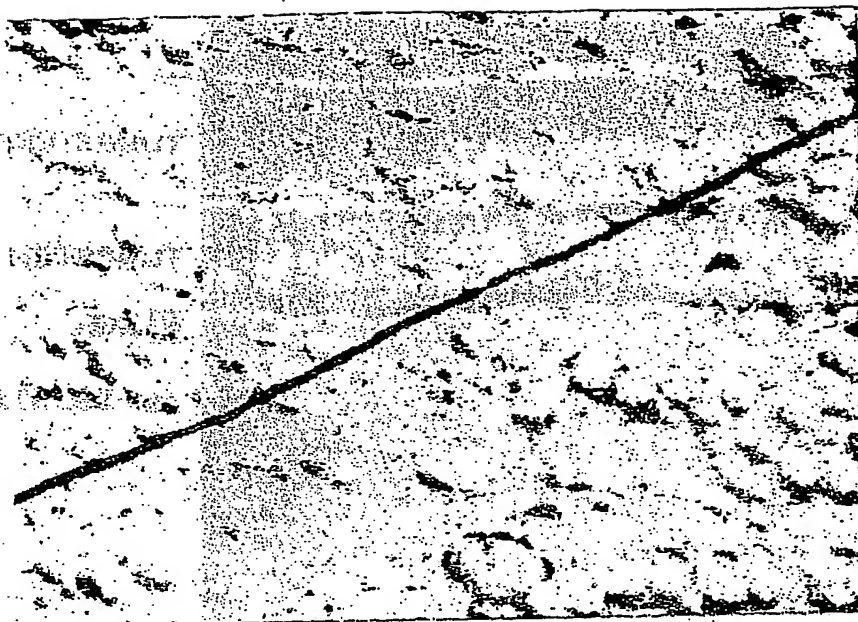
FIG. 6C

Figure 6C is a photomicrograph, magnified 1000 times, of a coating on AM-350 stainless steel substrate heat treated in-situ for 60 minutes followed by external heat treatment for 720 minutes at 500 °C showing cracks in the coating.

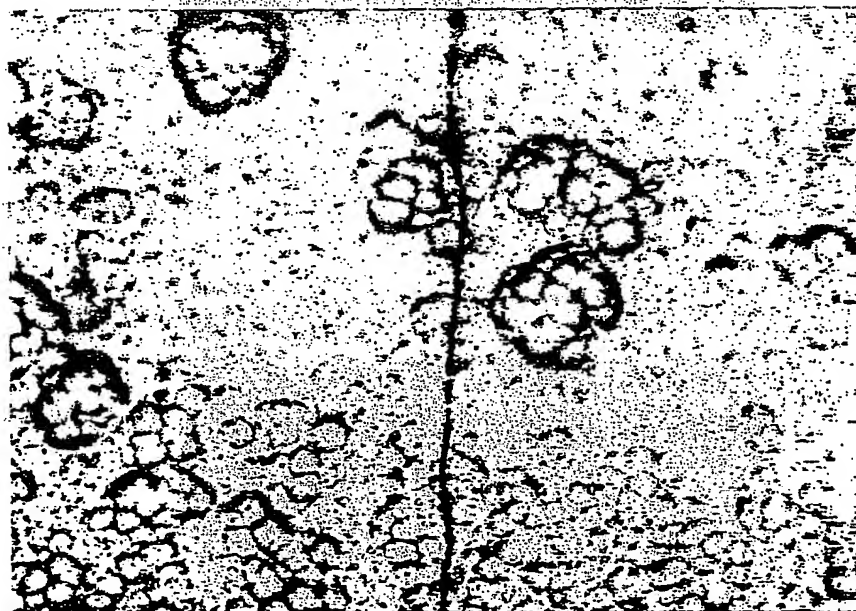
FIG. 6D

Figure 6D is a photomicrograph, magnified 1000 times, of a coating on Ti/6Al/4V substrate heat treated in-situ for 60 minutes followed by external heat treatment for 720 minutes at 500 °C showing cracks in the coating.

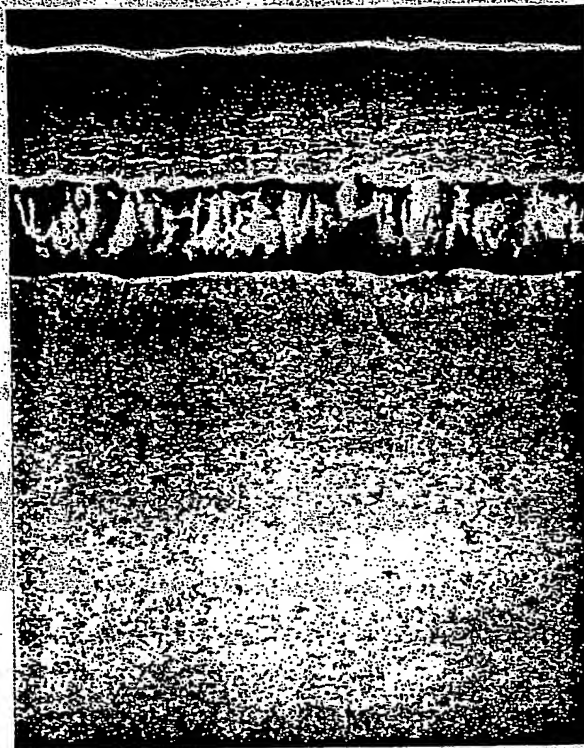
FIG. 7A

Figure 7A is a photomicrograph, magnified 200 times, of an etched cross section of a coating system according to the invention on AM-350 stainless steel substrate heat treated in-situ for 60 minutes followed by external heat treatment for 720 minutes at 550 °C showing the absence of non-uniformity in the microstructure.

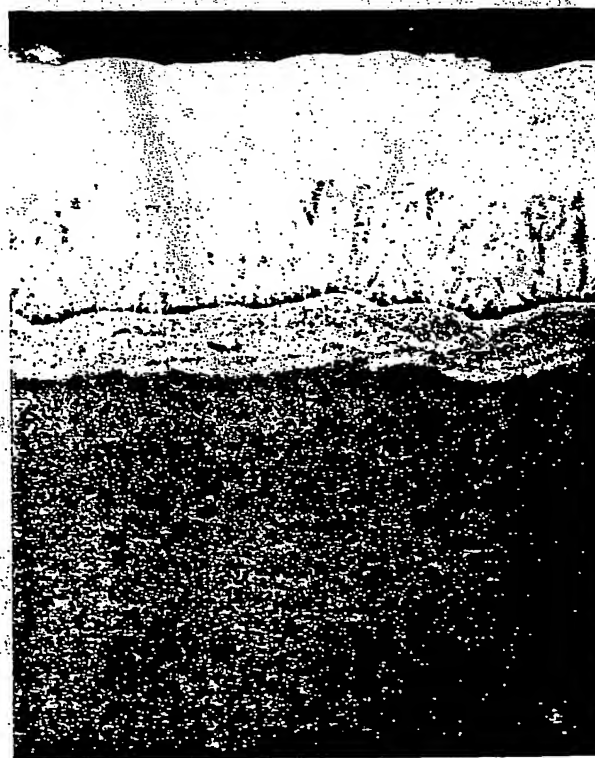
FIG. 7B

Figure 7B is a photomicrograph, magnified 2000 times, of an etched cross section of a coating system according to the invention on Ti/6Al/4V substrate heat treated in-situ for 60 minutes followed by external heat treatment for 720 minutes at 550 °C showing the absence of non-uniformity in the microstructure and the formation of an intermetallic titanium-nickel compound.

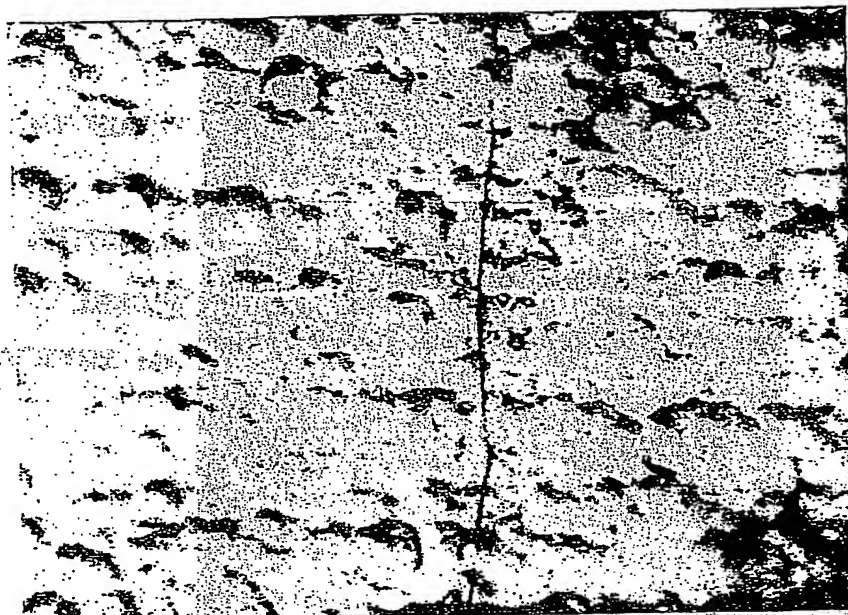
FIG. 8A

Figure 8A is a photomicrograph, magnified 1000 times, of a coating on AM-350 stainless steel substrate heat treated in-situ for 60 minutes followed by external heat treatment for 720 minutes at 600 °C showing cracks in the coating.

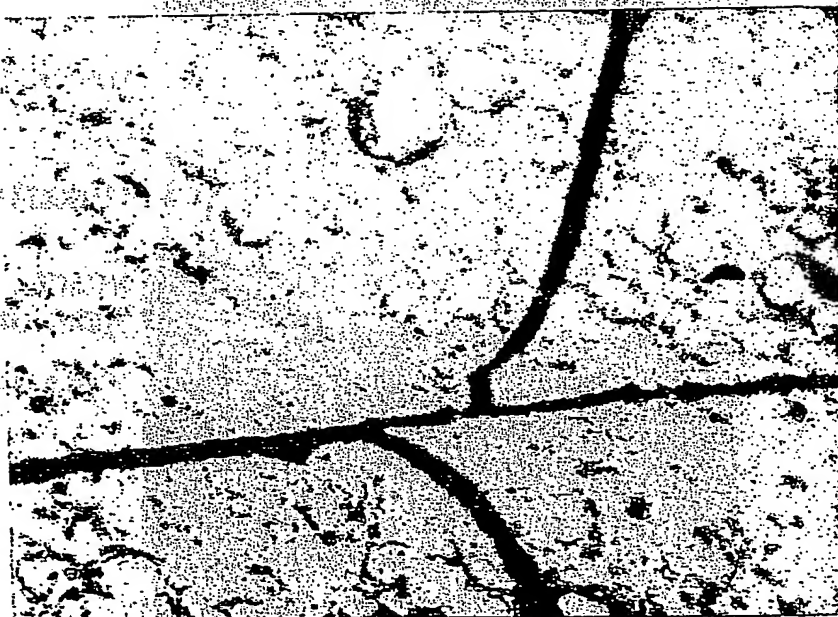
FIG. 8B

Figure 8B is a photomicrograph, magnified 1000 times, of a coating on Ti/6Al/4V substrate heat treated in-situ for 60 minutes followed by external heat treatment for 720 minutes at 600 °C showing cracks in the coating.

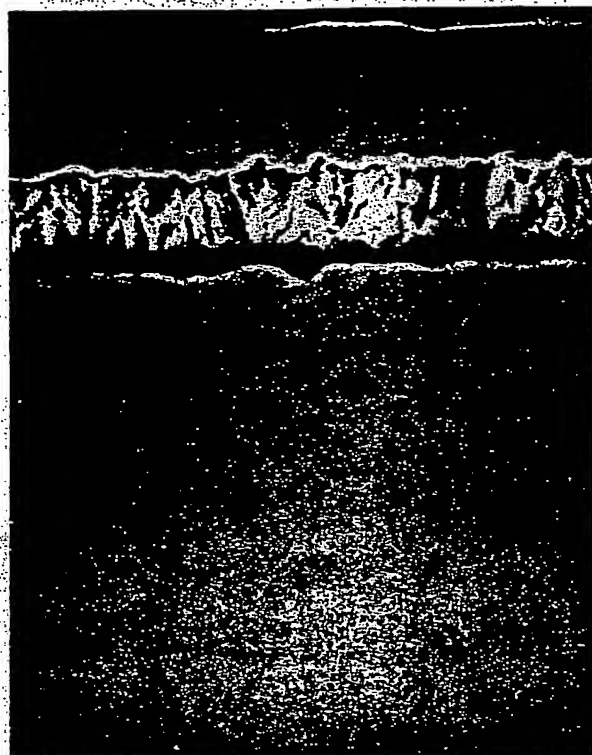
FIG. 8C

Figure 8C is a photomicrograph, magnified 2000 times, of an etched cross section of a coating system according to the invention on AM-350 stainless steel substrate heat treated in-situ for 60 minutes followed by external heat treatment for 720 minutes at 600 °C showing the absence of non-uniformity in the microstructure.

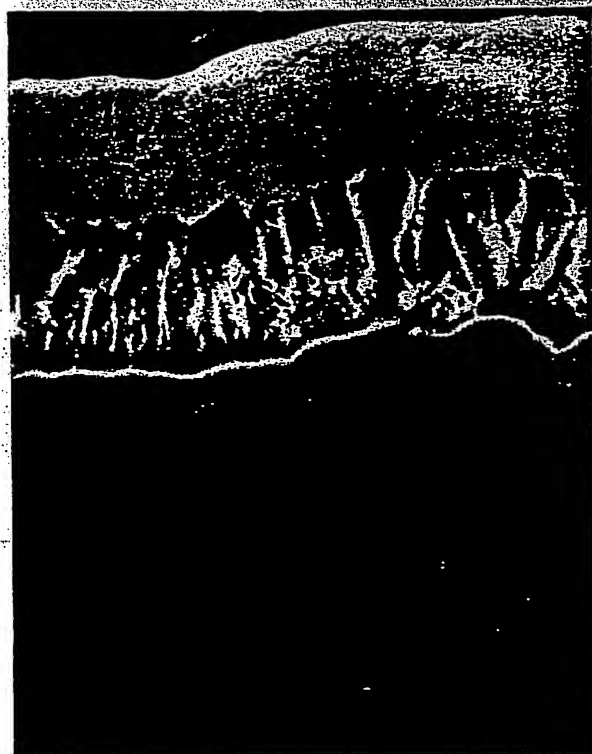
FIG. 8D

Figure 8D is a photomicrograph, magnified 2000 times, of an etched cross section of a coating system according to the invention on Ti/6Al/4V substrate heat treated in-situ for 60 minutes followed by external heat treatment for 720 minutes at 600 °C showing the absence of non-uniformity in the microstructure and the formation of an intermetallic titanium-nickel compound.

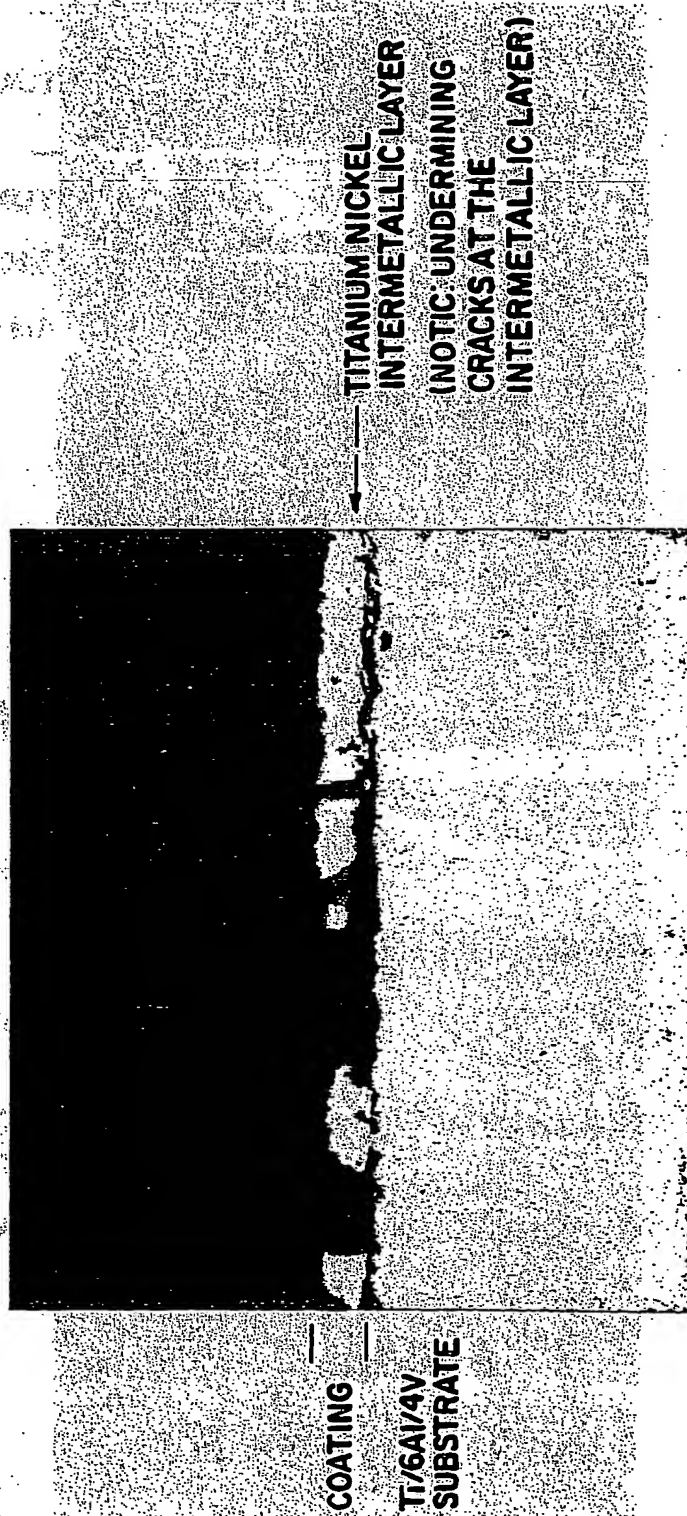
FIG. 9

Figure 9 is a photomicrograph, magnified 500 times, of a cross section of a coating system on Ti/6Al/4V substrate heat treated in-situ for 60 minutes followed by external heat treatment for 720 minutes at 600 °C showing the failure of the coating during the erosion test.
